**La Cuentista 1 HOA**  
**Albuquerque, NM**

Report #: 54969-0  
Beginning: January 1, 2027  
Expires: December 31, 2027

**RESERVE STUDY**  
**"Full"**

August 26, 2026

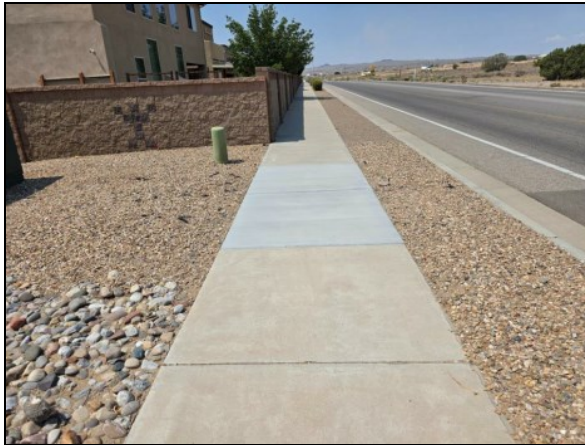
**Comp #: 2107 Concrete Sidewalks - Repair/Replace****Approx Quantity: 19,120 GSF****Location:** Adjacent to and within Common Area responsibility.**Funded?:** Yes. Meets the CAI Reserve Study Standards three-part test.**History:** Unknown specific history. Client reports sections replaced. Identified as lighter color. ~ 240 GSF replaced for \$2,654.**Comments:** Good condition: Concrete sidewalks determined to be in good condition typically exhibit smooth surfaces with positive slopes. If present, cracking is minimal/sporadic and any trip hazards are isolated and not substantial in quantity. Normal signs of wear and age evident at the time of inspection.

**Useful Life:**  
4 years**Remaining Life:**  
0 years

Sidewalks should be regularly inspected by the Client. Any evident trip and fall hazards should be repaired immediately to minimize potential risk/liability and promote safety. In our experience, larger repair/replacement expenses emerge as the community ages, especially as trees adjacent to sidewalks continue to grow. Although difficult to predict timing, cost and scope, we suggest a rotating "supplemental" allowance to fund periodic larger repairs to provide funds of 5% of the total square footage that may be required over time. All maintenance, repair, and/or other related expenditures should be tracked and reported by the Client during future Reserve Study updates. This component should then be re-evaluated based on most recent information and data available at that time.

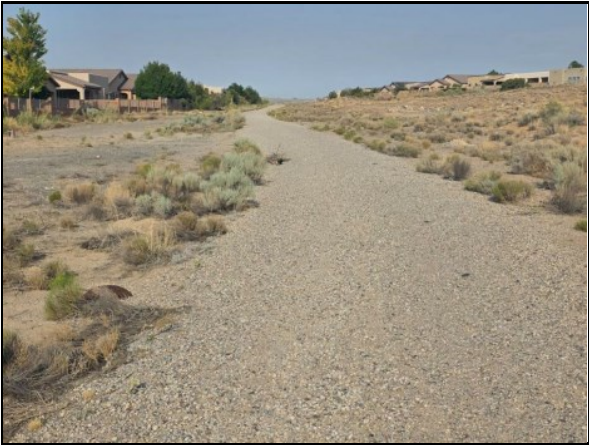
**Comp #: 2119 Gravel - Roadways - Repair/Replenish**

**History:** Assuming it is original. No history available.

**Comments:** This service road is primarily used as a walking trail, but was placed as a service entrance to Tract 1 for drainage maintenance and equipment access to the detention pond off of Rosa Parks Road. As routine maintenance, gravel roads should be inspected to identify any physical issues such as erosion and loss of material. Life expectancy related to this component are deemed to be too indeterminate for Reserve funding at this time. However, any significant information or expenditures related to this component (other than routine maintenance) should be tracked/reported by the Client. This component should then be re-evaluated during future Reserve Study updates based on most recent information and data available at that time. If deemed appropriate for Reserve funding, component can be included in the funding plan at that time.

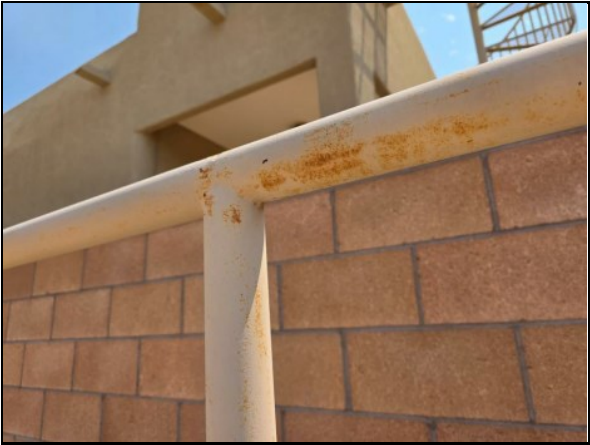
**Useful Life:**  
5 years

**Remaining Life:**  
1 years

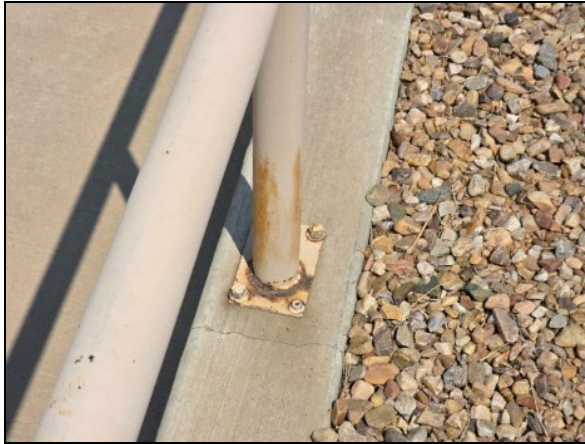
**Useful Life:**  
30 years

**Remaining Life:**  
10 years

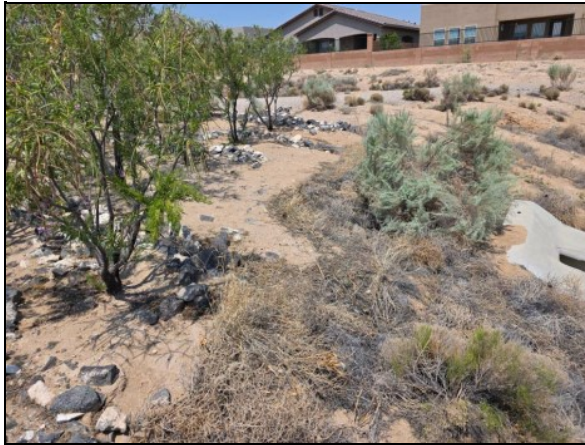
**Useful Life:**  
50 years

**Remaining Life:**  
3 years

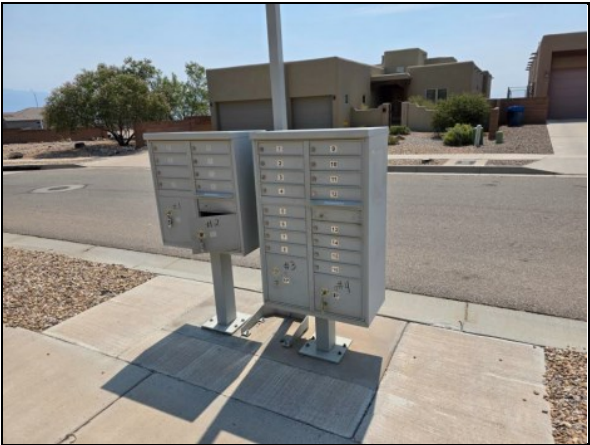
**Useful Life:**  
25 years

**Remaining Life:**  
6 years

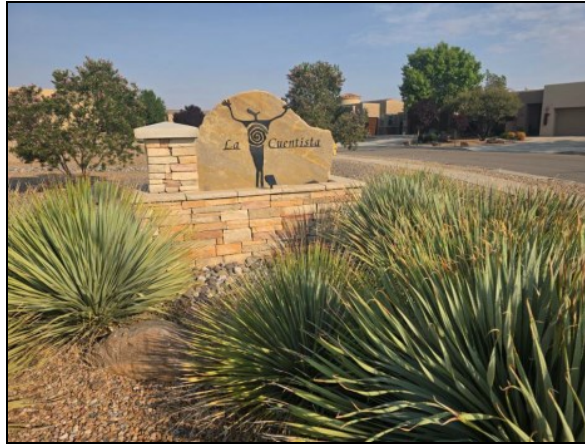
**Useful Life:**  
25 years

**Remaining Life:**  
13 years

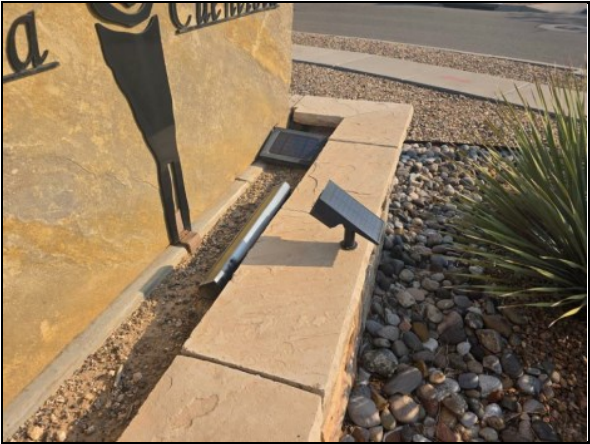
**History:** Unknown history.

**Comments:** Landscape light fixtures are generally considered to have little to no aesthetic value and do not typically need to be replaced all at one time. Individual replacement cost estimates related to this component are not expected to meet the minimum threshold for Reserve funding. As such, costs related to this component are expected to be included in the Client's Operating budget. However, any repair and maintenance or other related expenditures should be tracked, and this component should be re-evaluated during future Reserve Study updates based on most recent information and data available. If deemed appropriate for Reserve funding, component can be included in the funding plan at that time.

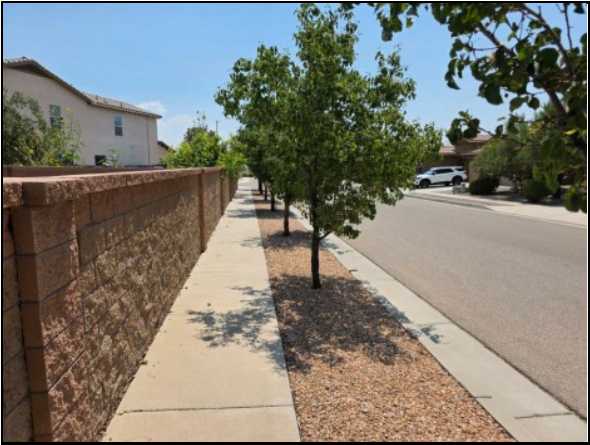
**Useful Life:**  
5 years

**Remaining Life:**  
0 years

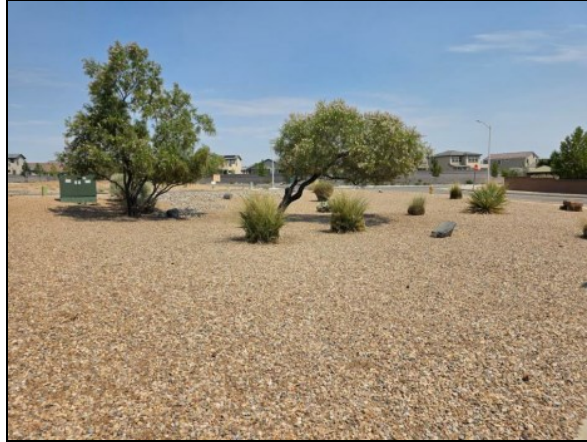
**Comments:** Routine landscaping is expected to be included within the Clients landscaping contract or otherwise reflected in the annual Operating budget. We recommend consulting with a qualified landscaping professional to create a long term plan for the care and management of the landscaping within the community. Based on correspondence with the Client and/or other information provided during this engagement, all potential landscaping refurbishment projects are expected to be handled through the Client's Operating budget. However, this component should be re-evaluated during future Reserve Study updates and funding incorporated (if necessary) based on the most current information available at that time.
